## HOME INSPECTIONS

### Home Inspection Report

XXX W. Dameron St., Long Beach, CA 90805

021919JH1

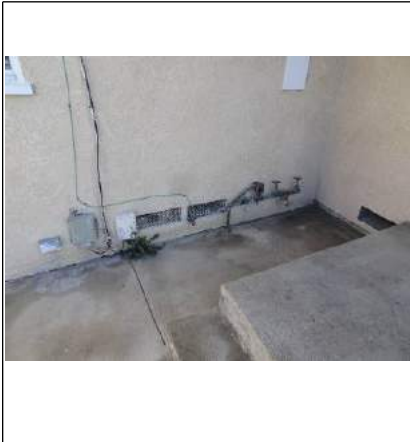
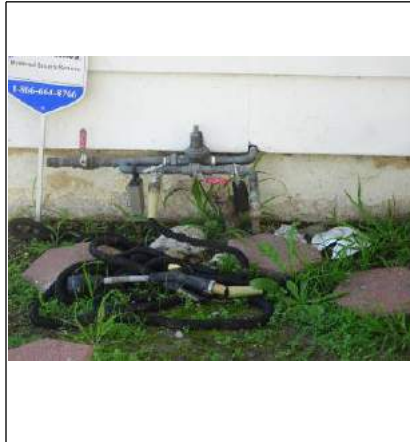
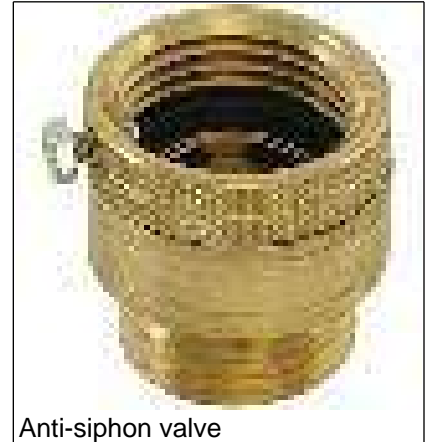
**Condition**  Satisfactory  Marginal  Poor  No anti-siphon valve  Recommend Anti-siphon valve

Anti-siphon valve

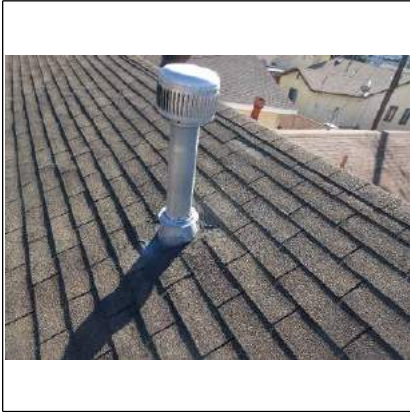
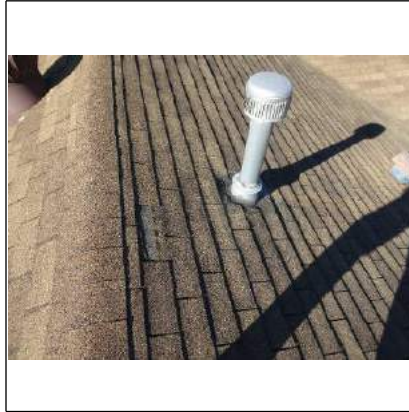
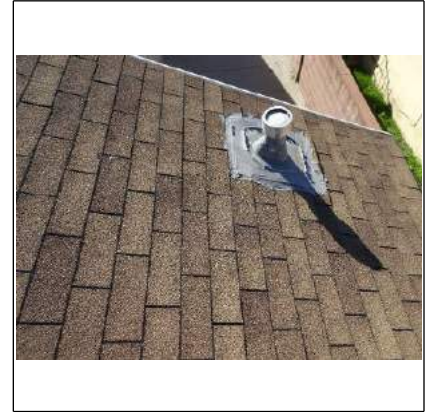
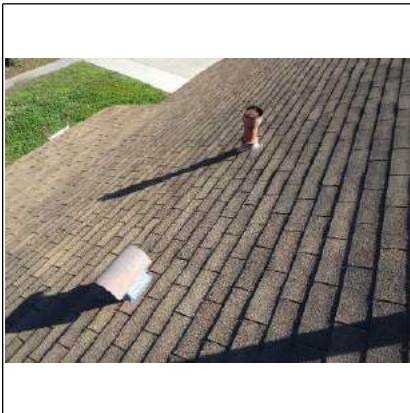
**Comments**    Plumbing vent flashing is under shingles downhill of the roof protrusion. This could allow moisture under shingle resulting in a possible roof leak. Recommend evaluation by a roofing contractor for repairs as needed.

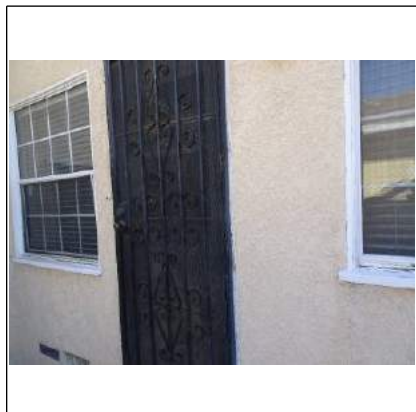
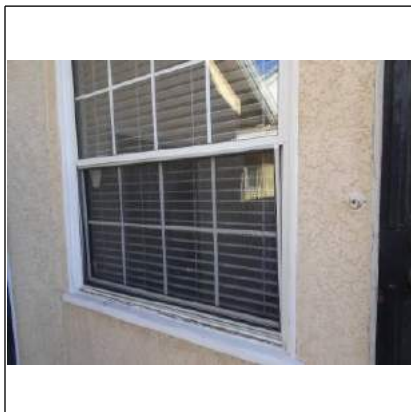
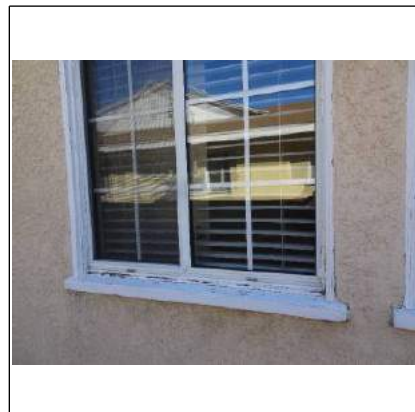
**Comments** Some wood trim was in need of normal painting maintenance to protect wood from wood destroying organisms.

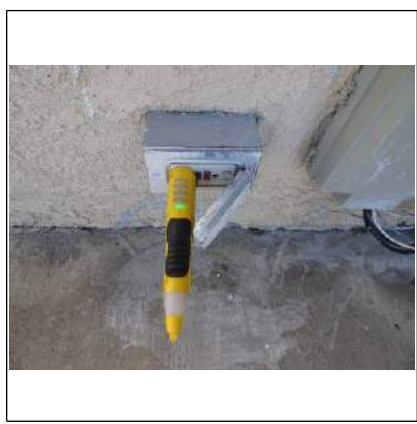
**Comments** GFCI on rear exterior receptacle does not function. Potential safety hazard. Recommend evaluation by a licensed electrician for replacement.

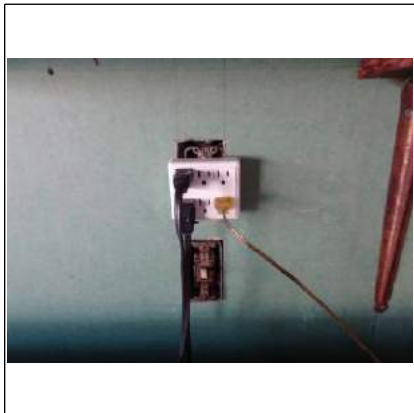
**Comments** Garage electrical receptacles not equipped with GFCI. Recommend installation of GFCI receptacles as an upgrade to increase safety.  
Cover plate missing from electrical receptacle and switch in garage. Recommend evaluation by a licensed electrician for repairs as needed.

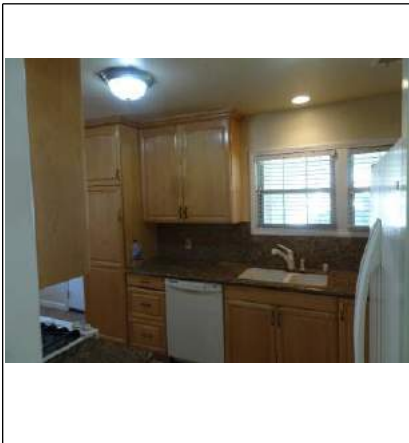
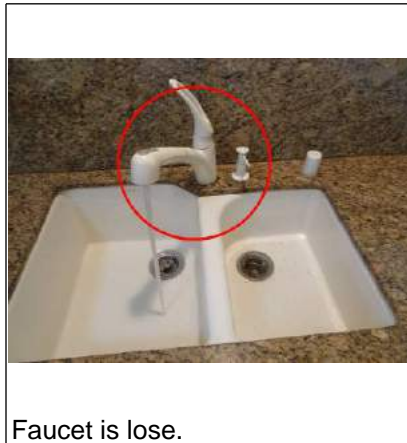
Comments Faucet fixture is loose on kitchen sink. Recommend evaluation by a licensed plumber for repairs as needed.

Faucet is loose.

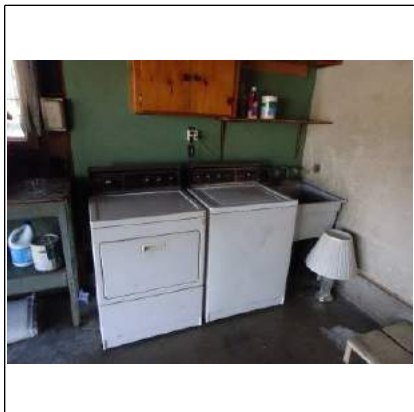
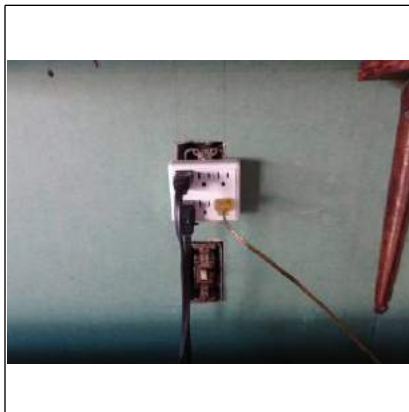
Comments GFCI not required at time of construction. GFCI recommend for washer appliances as an upgrde to increase safety.

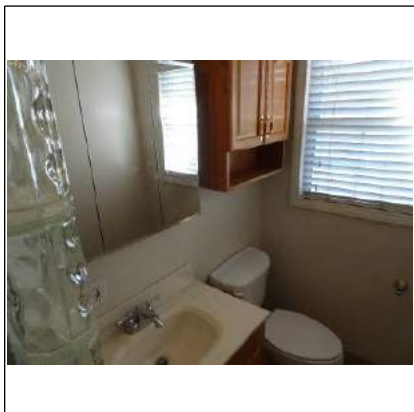
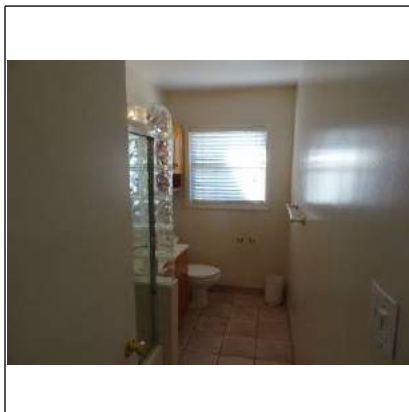
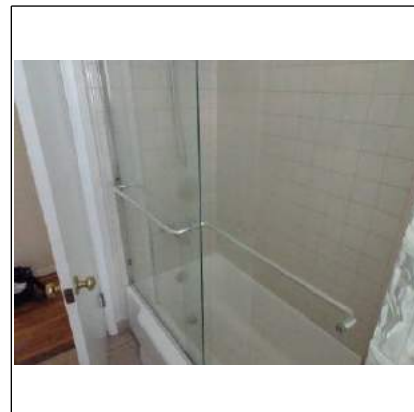
**Comments** Faucet handle(s) lose in bathtub. Recommend evaluation by a licensed plumber for repairs as needed. Cable/spring on window not functioning. Windows does not stay up. Recommend evaluation by a licensed contractor for repairs as needed.

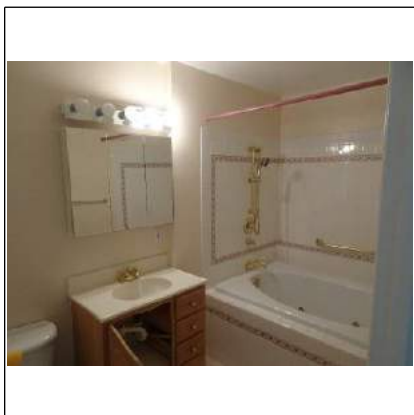
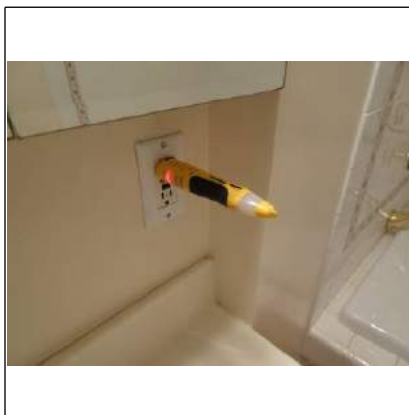
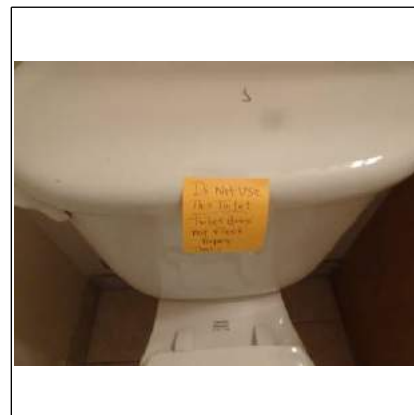
**Comments** Toilet not tested at request of seller. Recommend verifying condition of toilet prior to close of sale.  
Whirlpool power button stuck. Recommend evaluation by a licensed plumber for repairs as needed.

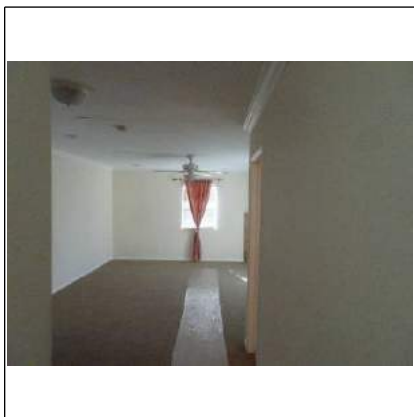
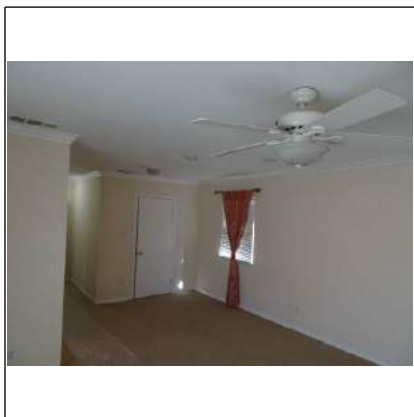
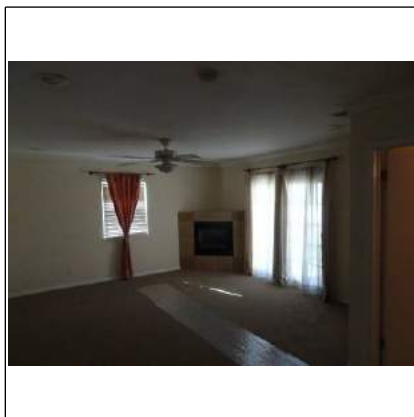
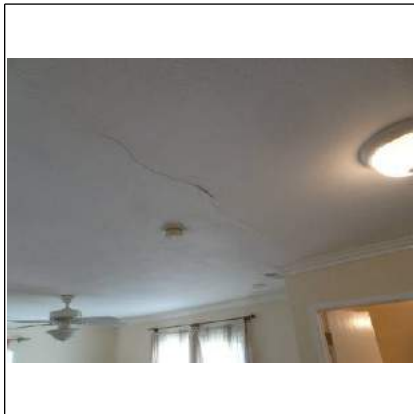
Where: Settlement crack noted in ceiling/walls. Recommend evaluation by a licensed contractor for repairs as needed.

**Comments** Ceiling fan appears to be operated via remote which could not be located. Fan not tested.  
Fireplace appears to be operated via remote which lacked batteries. Fireplace was not inspected.  
Recommend confirming operation with seller prior to close of sale.

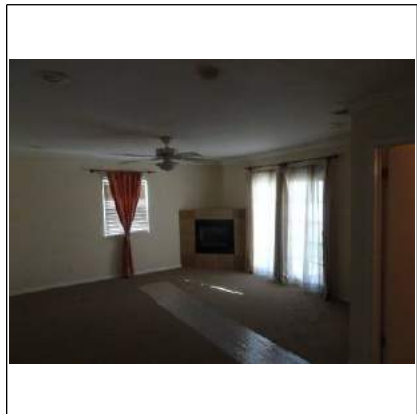
**Comments** Fireplace appears to be operated via remote control which lacked batteries. Fireplace therefore was not inspected. Recommend verifying operation with seller prior to close of sale.

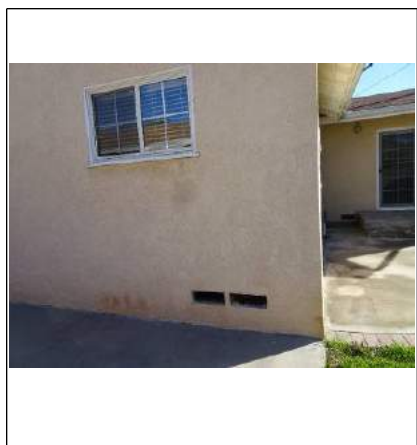
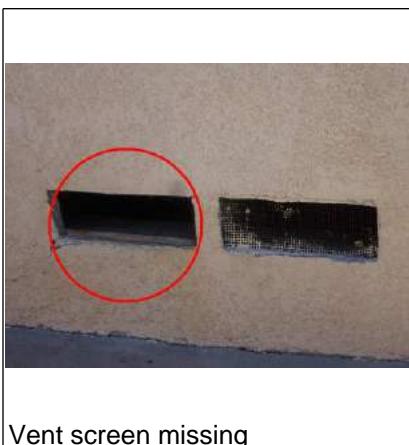
**Comments** Vent screen missing on southwest side of residence. Recommend installing vent screen to prevent intrusion of pest and wildlife.

Vent screen missing

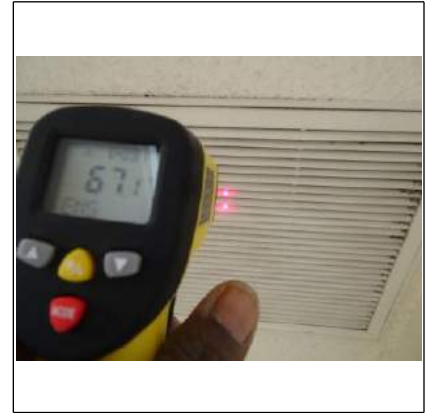
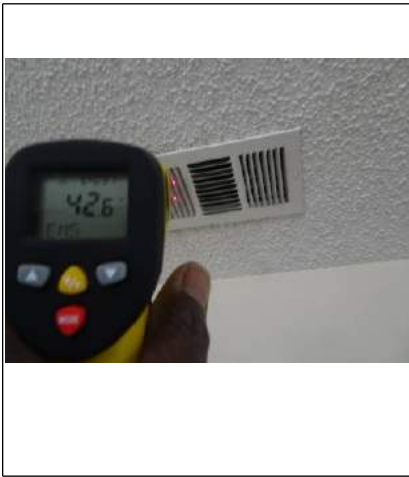
Filter not appropriate size for intake.
