## HOME INSPECTIONS

### Home Inspection Report

XXX W. Dameron St., Long Beach, CA 90805

021919JH1

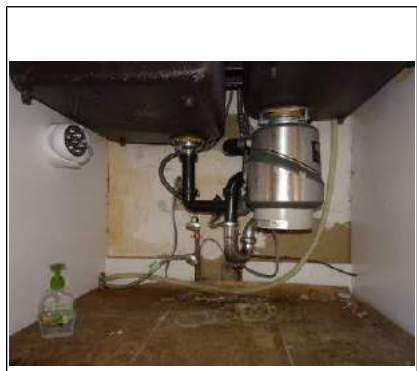
Disposal not operational

Garbage disposal not operating. Recommend evaluation by a licensed plumber for repairs as needed.  
Toilet in master bathroom noted by seller to be non-operational. Recommend verifying operation with seller prior to close of sale.  
Pump switch stuck on whirlpool tub. Recommend evaluation by a licensed plumber for repairs/replacement as needed.

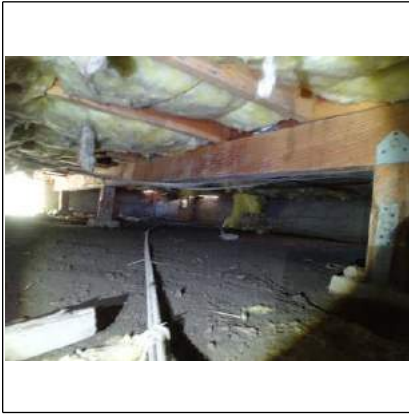
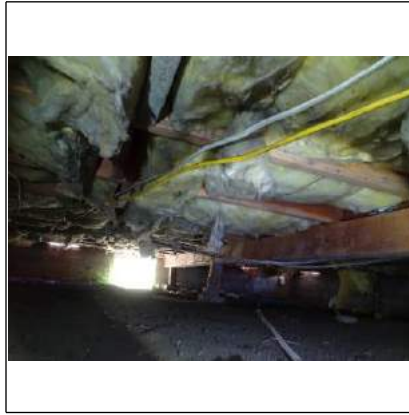
**Comments** Vent screen missing on southwest side of residence. Recommend installing vent screen to prevent intrusion of pest and wildlife.

Vent screen missing

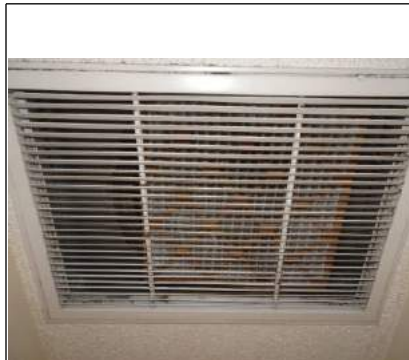
Filter not appropriate size for intake.
